Manhole Inspection Summary

Manhole # S13SS_036MH

Insp Date: **7/22/09 12:32 PM**

Location Address: **2731 DUKELAND ST**

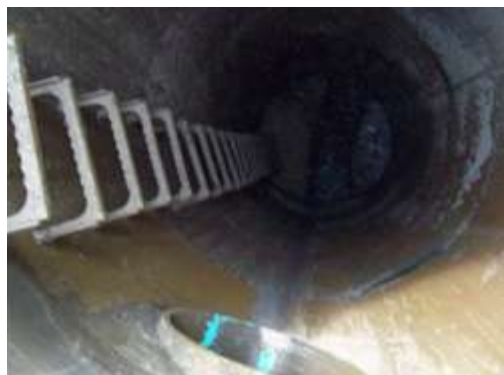
Top View

Condition: **Sound**

Condition: ☒ Sound ☐ Cracked ☐ Leaks

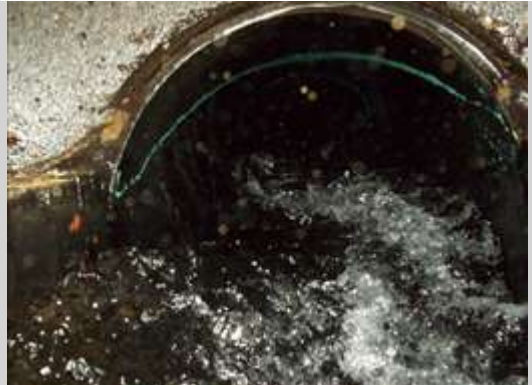
12 O'Clock Outflow

18 in. Circular Gravity Sewer
Pipe Out @ 12 O'Clock

Pipe Material: **PVC** ☐ Pipe Lined

Invert Depth: **23.30** (ft.) Flow Characteristics: **Fast**

Deposits: ☒ None ☐ Mud ☐ Sludge ☐ Debris ☐ Grease

Infiltration: **None** Pipe Seal Cond: **Sound**

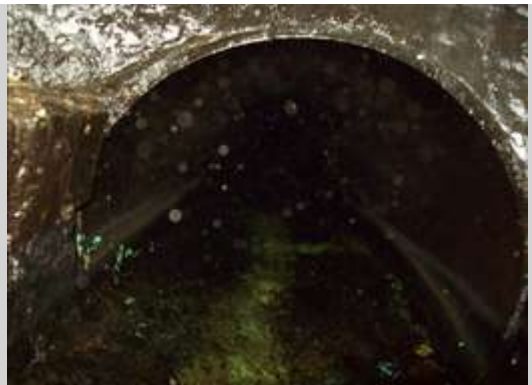
6 O'Clock Inflow

18 in. Circular Gravity Sewer
Pipe In @ 6 O'Clock

Pipe Material: **PVC** ☐ Pipe Lined

Invert Depth: **23.25** (ft.) Flow Characteristics: **Fast**

Deposits: ☒ None ☐ Mud ☐ Sludge ☐ Debris ☐ Grease

Infiltration: **None** Pipe Seal Cond: **Sound**

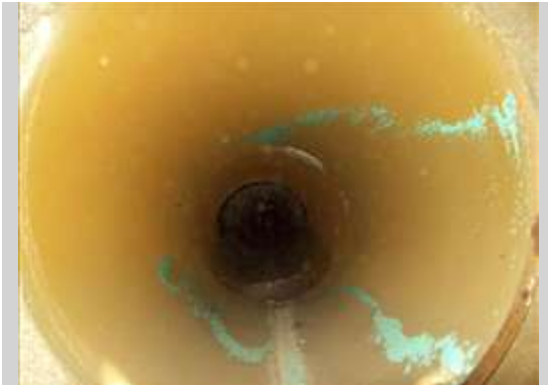
6 O'Clock Inflow

18 in. Circular Gravity Sewer

Pipe In @ 6 O'Clock

Pipe Material: **PVC** ☐ Pipe Lined

Invert Depth: **5.50** (ft.) Flow Characteristics: **None**

Infiltration: **None**

Pipe Seal Cond: **Sound**

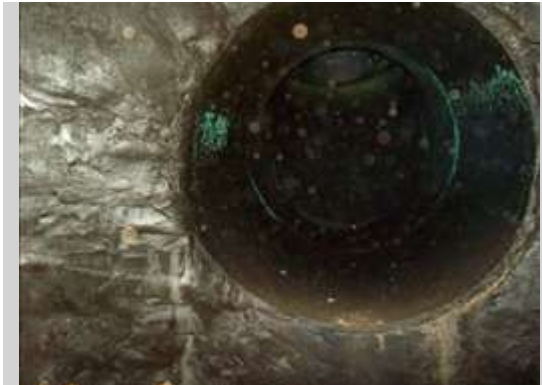
Drop In @ 6 O'Clock

DROP AT 20.45

Drop: **Inside** **Direct**

Inv Depth: **20.45** (ft.)

Drop Condition: **Open**
